Electrical Safety Alert

Apple Power Adapter Breaks in Outlet When Unplugged

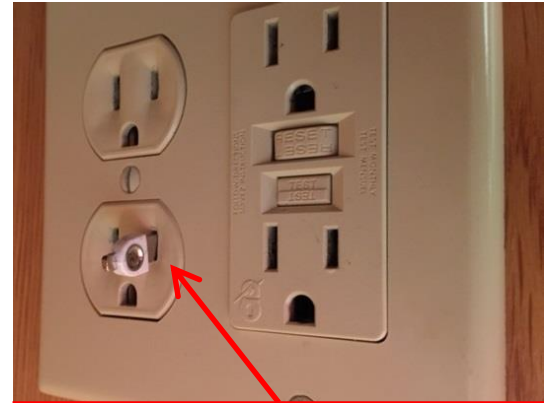
The Apple power adapter pictured below was powering an Apple (Mac) laptop, plugged in to a 120-Volt outlet. When the user, a Network Engineer, attempted to unplug the power adapter from the outlet, the blade in the “hot” side of the outlet broke free of the power adapter and remained in the outlet.

Broken Blade in “Hot” side of outlet
SERIOUS SHOCK HAZARD!

DO NOT attempt to remove a broken device from an outlet! Call a Qualified Electrical Worker (QEW) to assist in removal and repair or replacement of damaged equipment.

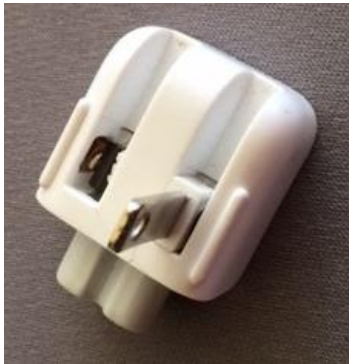
Power Adapter With Broken Blade

Perform a visual inspection of your plug-connected equipment before each use, per Section 5.4.4 of the Electrical Safety Manual. Look for cracks in the plastic, loose parts, and deformed or missing pins. In the case of the Apple-branded power adapter pictured here, both blades should move simultaneously. If the blades move independently, the adapter needs to be replaced.

The power adapter may be replaced as a whole, or the wall adapter portion (Volex APC7D) can be replaced. Genuine Apple-branded products are recommended to avoid counterfeit products. Any replacement product for use at LBNL must have NRTL listing or recognition.

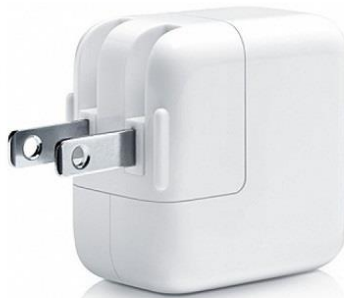
Original Condition of Power Adapter

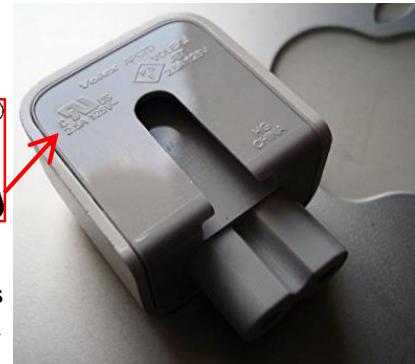
Genuine Volex APC7D Wall Adapter
